Monitoring Data Record

Project Title: R-2417BB (Site 6) COE Action ID: 200201326
 Stream Name: _____ DWQ Numbers: 3378
 City, County and other Location Information: Lee County, Sanford Bypass (Sta. 540+20 to 555+00 -L- RT.)
 Date Construction Completed: Water was turned into the stream in Oct. 2006. Streambank reforestation was completed in Jan. 2007.
 Monitoring Quarter: (1) of 8
 Ecoregion: _____ 8 digit HUC unit: 03030004
 USGS Quad Name and Coordinates: _____

Site 6

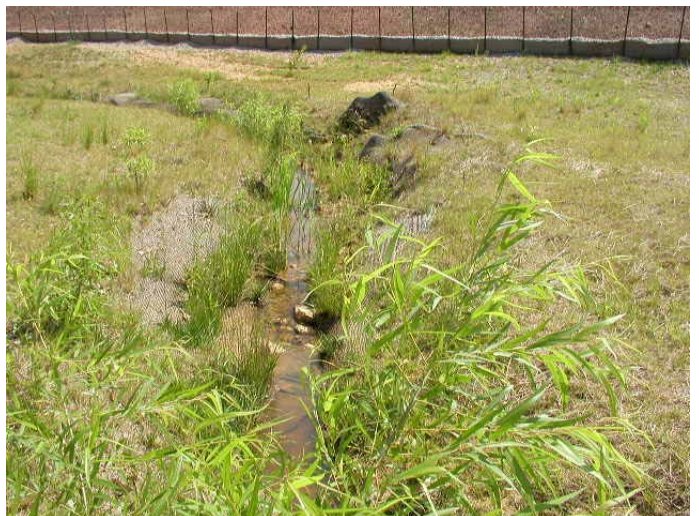
Photo Point #6 (Downstream)

5/21/07	PP #6 Upstream Sta. 546 +75	PP #7 Downstream Sta. 545+60	Station Number	Station Number	Station Number
Structure Type	Crossvane	Crossvane			
Is water piping through or around structure?	Water is piping through the crossvane	Water is piping through the crossvane			
Head cut or down cut present?	Slight headcut				
Bank or scour erosion present?					
Other problems noted?
